# Manhole Inspection Summary

Manhole # S47II\_012MH

Insp Date: **5/2/08 8:55 AM**

**Location** Address: **Collington Ave**

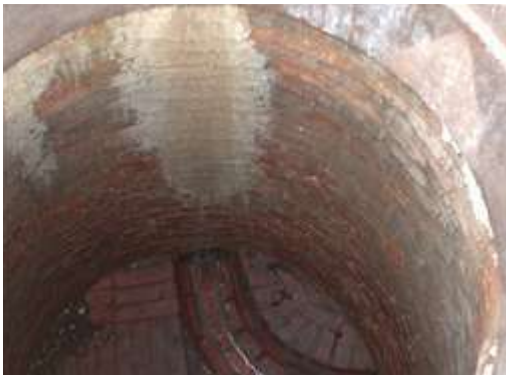
Defect 2

Infiltration: ☐ None ☐ Joint ☐ Cracks ☐ Mortar ☐ Roots ☒ **Wall**

Infiltration

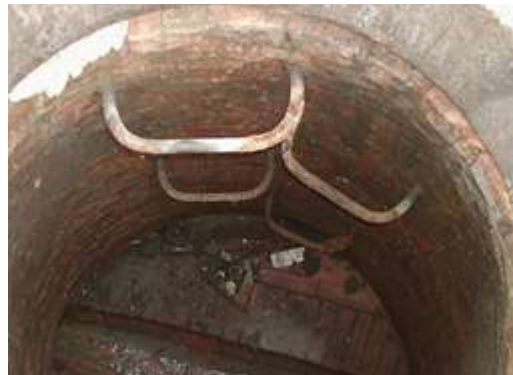
Defect 1

Condition: ☐ Sound ☐ Cracked ☐ Root Intrusion ☐ Loose Brick ☒ **Deteriorated**

Deterioration

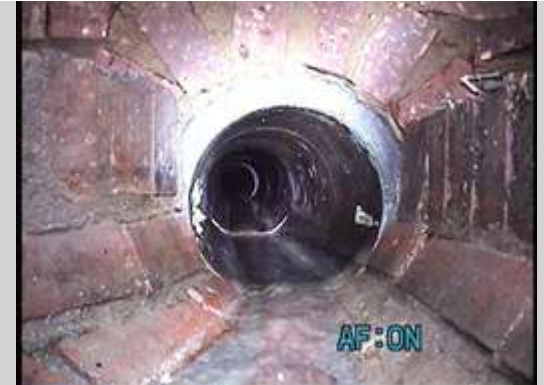
12 O'Clock Outflow

8 in. Circular Gravity Sewer  
Pipe Out @ 12 O'Clock

Pipe Height: **8.4** (in.) Rod and Bar (Angled)  
Pipe Material: **Clay** ☐ Pipe Lined  
Invert Depth: **8.40** (ft.) Flow Characteristics: **Fast**  
Deposits: ☒ None ☐ Mud ☐ Sludge ☐ Debris ☐ Grease  
Silt Depth: (in.) Deposits Extent:  
Infiltration: **None** Pipe Seal Cond: **Sound**

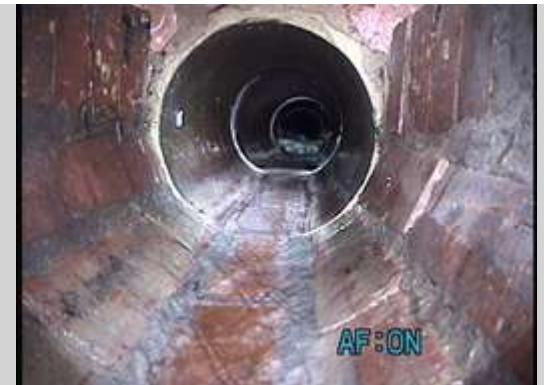
6 O'Clock Inflow

8 in. Circular Gravity Sewer  
Pipe In @ 6 O'Clock

Pipe Height: **8.4** (in.) Rod and Bar (Angled)  
Pipe Material: **Clay** ☐ Pipe Lined  
Invert Depth: **8.30** (ft.) Flow Characteristics: **Fast**  
Deposits: ☒ None ☐ Mud ☐ Sludge ☐ Debris ☐ Grease  
Silt Depth: (in.) Deposits Extent:  
Infiltration: **None** Pipe Seal Cond: **Sound**

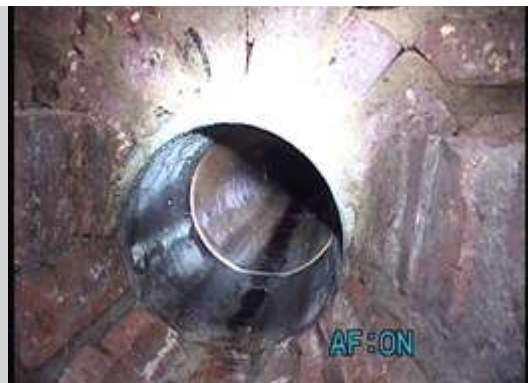
9 O'Clock Inflow

8 in. Circular Gravity Sewer  
Pipe In @ 9 O'Clock

Invert Depth: **8.35** (ft.) Flow Characteristics: **Slow**

Infiltration: **None** Pipe Seal Cond: **Sound**
